# Manhole Inspection Summary

Manhole # S37II\_027MH

Insp Date: **3/16/07 8:37 AM**

**Location** Address: **400 PITMAN PL**

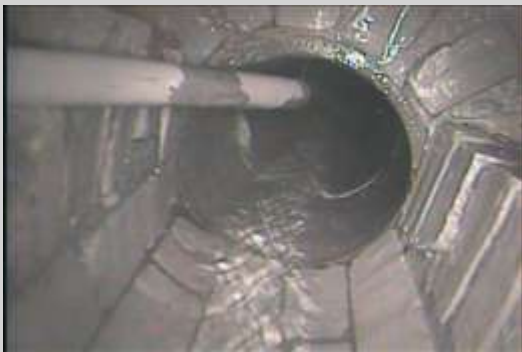
### 8 in. Circular Gravity Sewer Pipe Out @ 12 O'Clock

Rod and Bar (Angled)

Infiltration: **None** Pipe Seal Cond: **Unknown**
